**2007 American WJTA Conference and Expo
August 19-21, 2007 • Houston, Texas**

IMPACT OF RESIDUAL STRESSES ON ACCURACY OF AWJ CUTTING

Jay Zeng and John Olsen
OMAX Corporation
Kent, Washington, USA

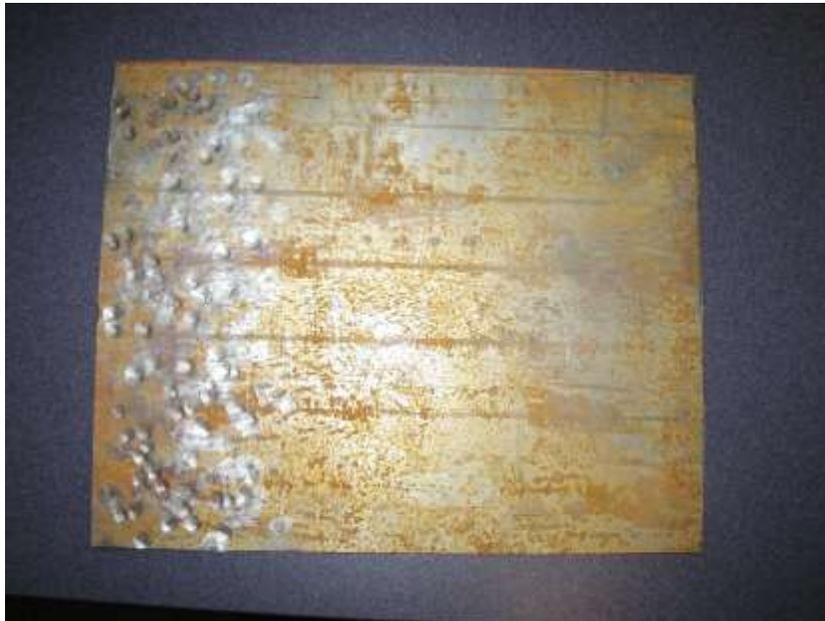
A piece of 3.175 mm ($\frac{1}{8}$ "") thick mild steel was hammered randomly on a portion of its top surface to create residual stresses (see Figure 1).

Figure 1. Steel plate was hammered to create residual stresses.

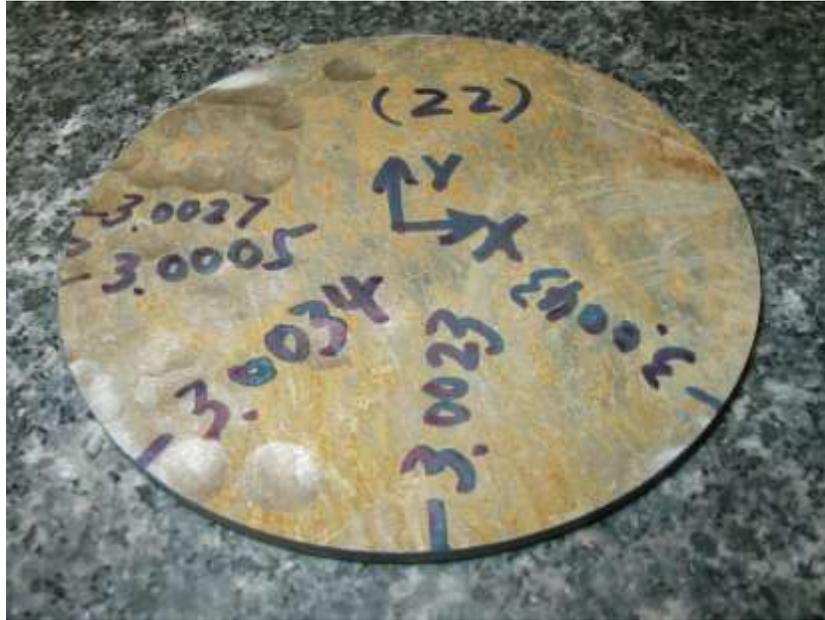
Then, a 3" round disc was cut with half of the disc on the hammered portion (Figure 2). The jet started and stopped at the spot marked with a "V" (at the 9 o'clock position), and the jet moved clockwise. Measurements of the diameters around the cut disc using a micrometer were recorded on its surface. The smallest diameter is near the 9 o'clock position (just ahead of stop), and the largest diameter is near the 4 o'clock position. The circularity error is 0.096 mm (0.0038").

Figure 2. Disc cut on the hammered portion of the steel plate.

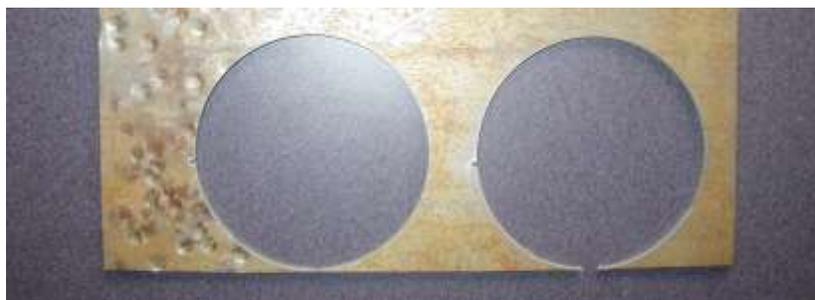
Another disc was cut on the same steel plate as in Case (1), but on the portion not having been hit with the hammer. The program unintentionally cut through the edge of the plate (Figure 3a), resulting in an open contour. The circularity error was measured at 0.201 mm (0.0079") (Figure 3b). This showed that the error associated with residual stresses can be intensified by an open contour.

Figure 3a. Disc cut through the edge on the un-hammered portion of the steel plate (to the right).

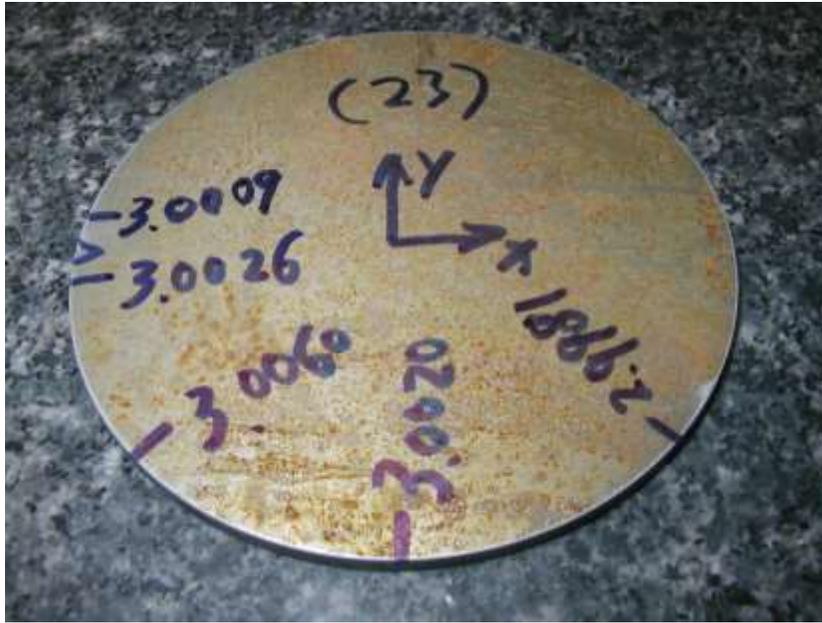
Figure 3b. Disc cut through the edge on the un-hammered portion of the steel plate.

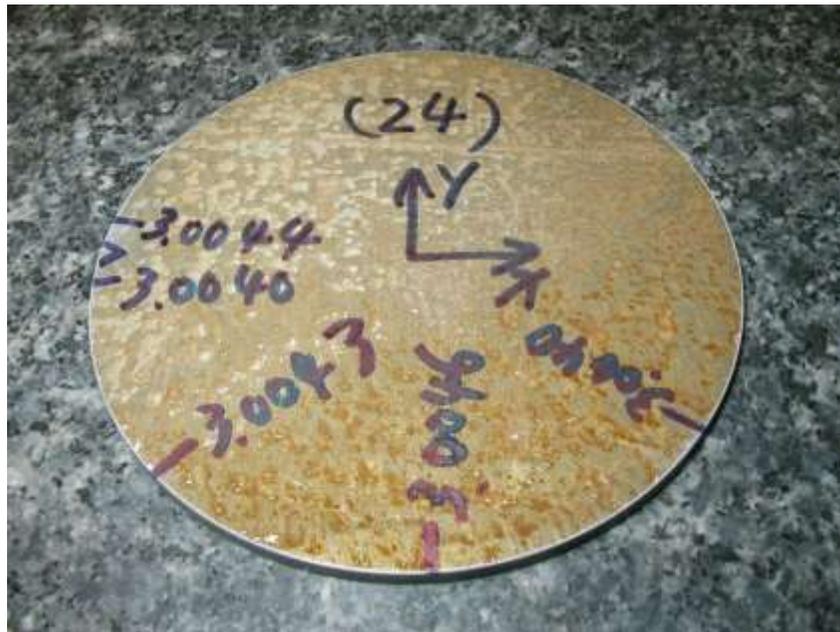
Another disc was cut using a piece of the same material without being hammered. The circularity error was 0.015 mm (0.0006") (Figure 4).

Figure 4. Disc cut on material with unknown status of residual stresses.

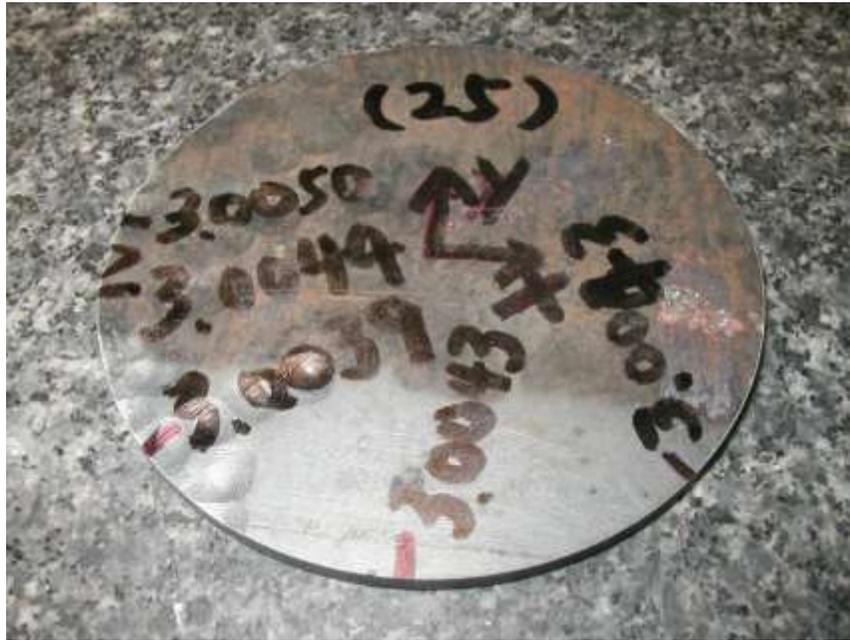
A material like that used in Case (1) was stress-relieved prior to cutting. The stress relief was done by heating the plate in an oven to 593°C (1100°F) for ½ hour, and then letting it cool in the oven to 427°C (800°F), followed by air cooling to room temperature. The part cut on the stress-relieved material had a circularity error of 0.028 mm (0.0011”), an improvement from 0.096 mm (0.0038”) as shown in Figure 5.

Figure 5. Disc cut on the hammered plate with stress relief.

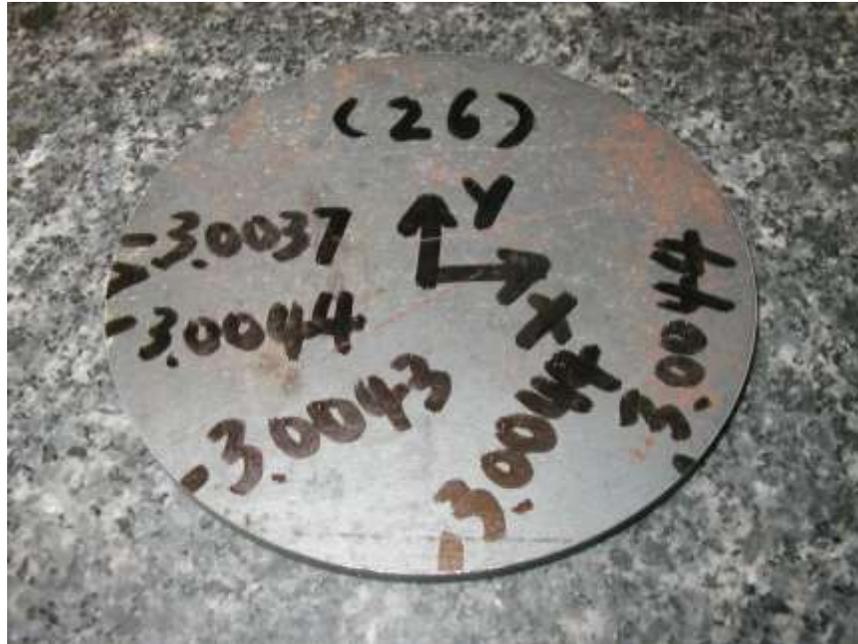
A material like that used in Case (2) was stress-relieved and then cut intentionally through the edge. The measured circularity error was 0.018 mm (0.0007”), an improvement from 0.201 mm (0.0079”) as shown in Figure 6.

Figure 6. Disc cut through the edge on material with stress relief.

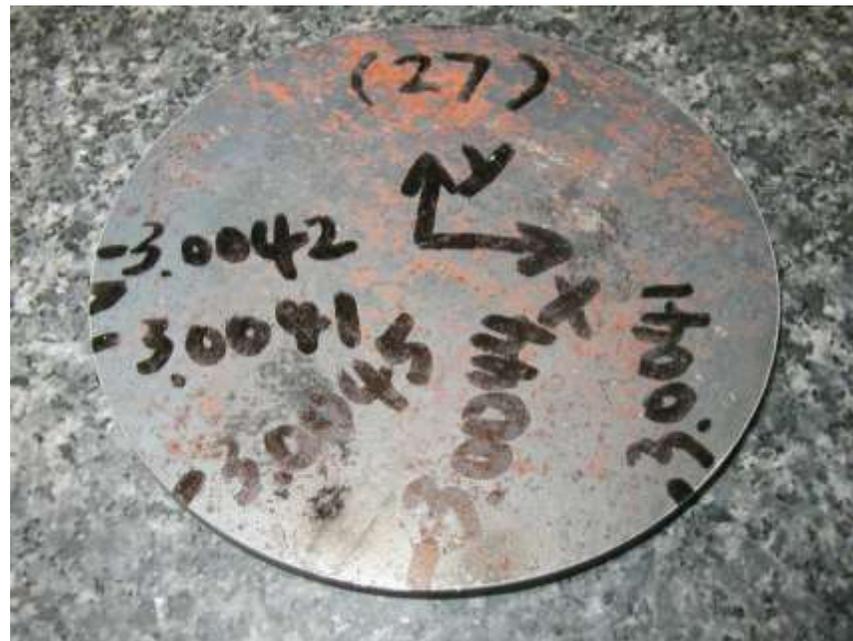
A material with an unknown residual stress status, like in Case (3), was stress-relieved, and then the round disc was cut. The measured circularity error was 0.010 mm (0.0004”), an improvement from 0.018 mm (0.0007”) as shown in Figure 7.

Figure 7. Disc cut on material with stress relief.

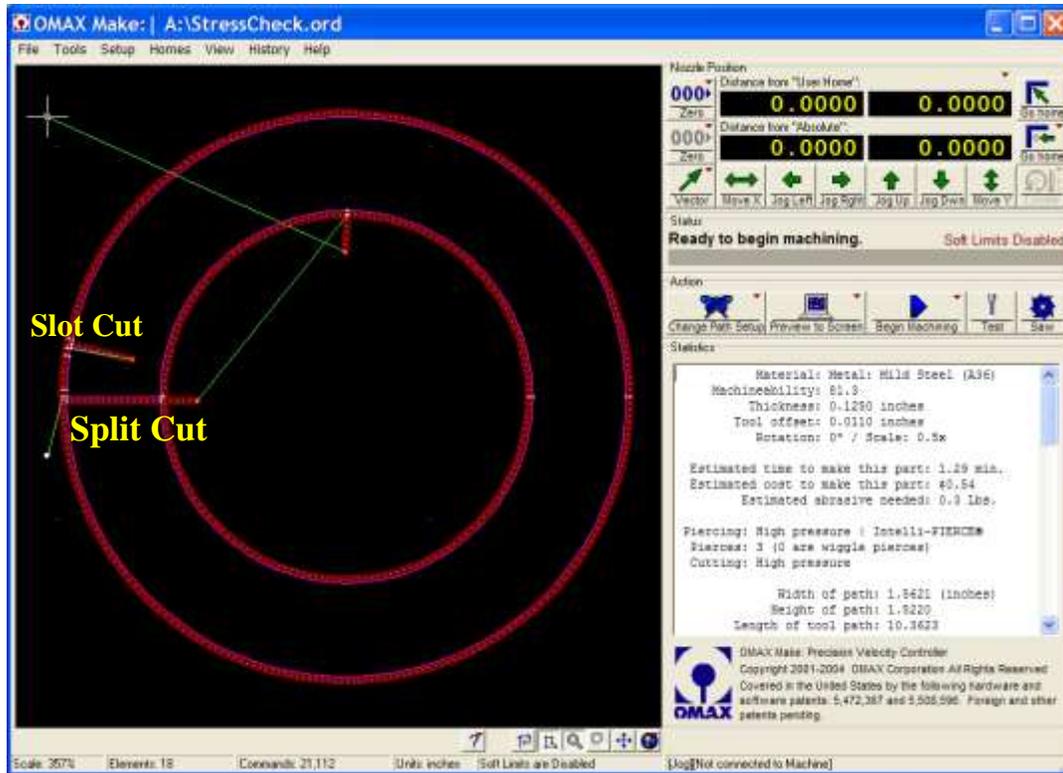
To prevent scrapping a critical part because of residual-stresses-related errors, a test part can be cut that determines if it is necessary to carry out a stress relief operation on the material. A program that works well for test cutting parts ("StressCheck.ord") is illustrated in Figure 8. A split ring cut on the subject material will reveal material distortion caused by residual stresses. A

single-pass slot cut near the split is useful for kerf comparison. Either or both of these two phenomena will indicate the existence of residual stresses: (1) the kerf width at the split is different from that at the slot; (2) the two ends of the split ring are no longer positioned on the same plane.

Figure 8. Split ring test part to detect residual stresses.

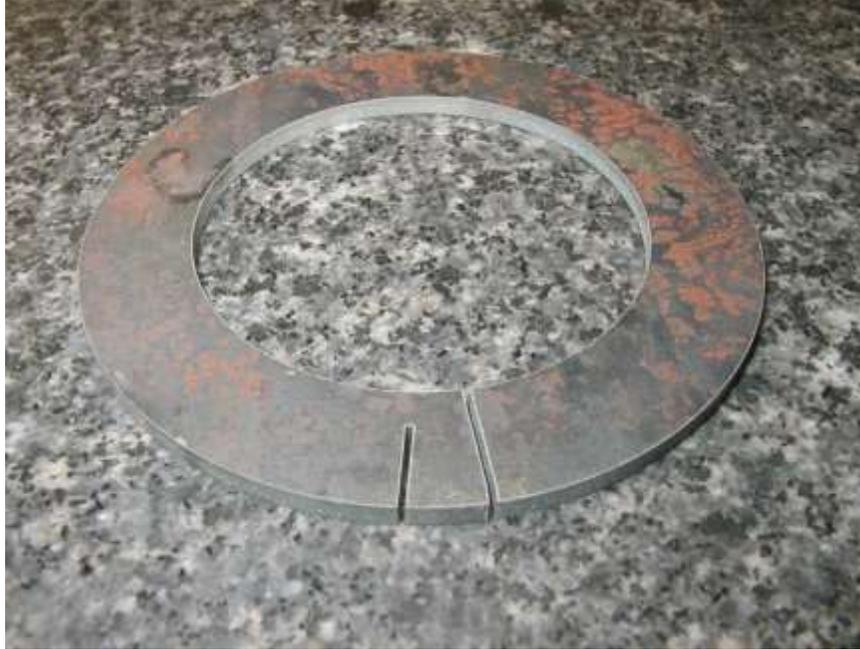
To prove that this is an effective method of detecting residual stresses, two split rings were cut on materials with and without residual stresses. One was cut on the same material as in Case (6) (with stress relief). The kerf width on the split exactly matches that on the slot and the two ends of the split are evenly on the same plane (no warping) (Figure 9).

Figure 9. Split ring cut on stress relieved material.

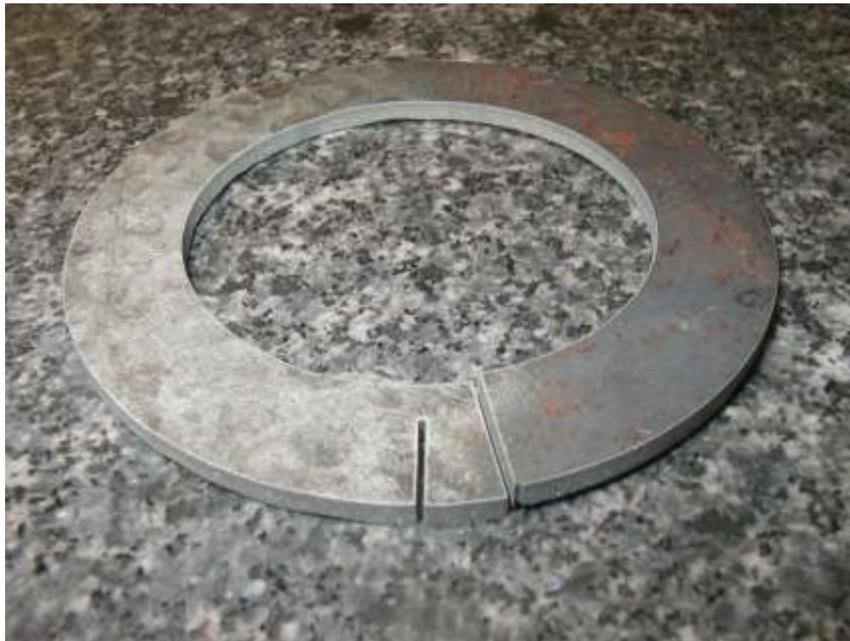
The other split ring was cut on the same material used in Case (1) (hammered to create residual stresses and without stress relief). The kerf width at the split is 0.508 mm (0.020") vs. 0.635 mm (0.025") at the slot. In addition, the two ends of the split have a height mismatching error of 1.32 mm (0.052") (Figure 10). This indicates that the material has residual stresses and should be stress-relieved prior to cutting.

Figure 10. Split ring cut on material having residual stresses.
